INFORMATION REPORT

CENTRAL INTELLIGENCE AGENCY

Poland

Port Information: Gdansk

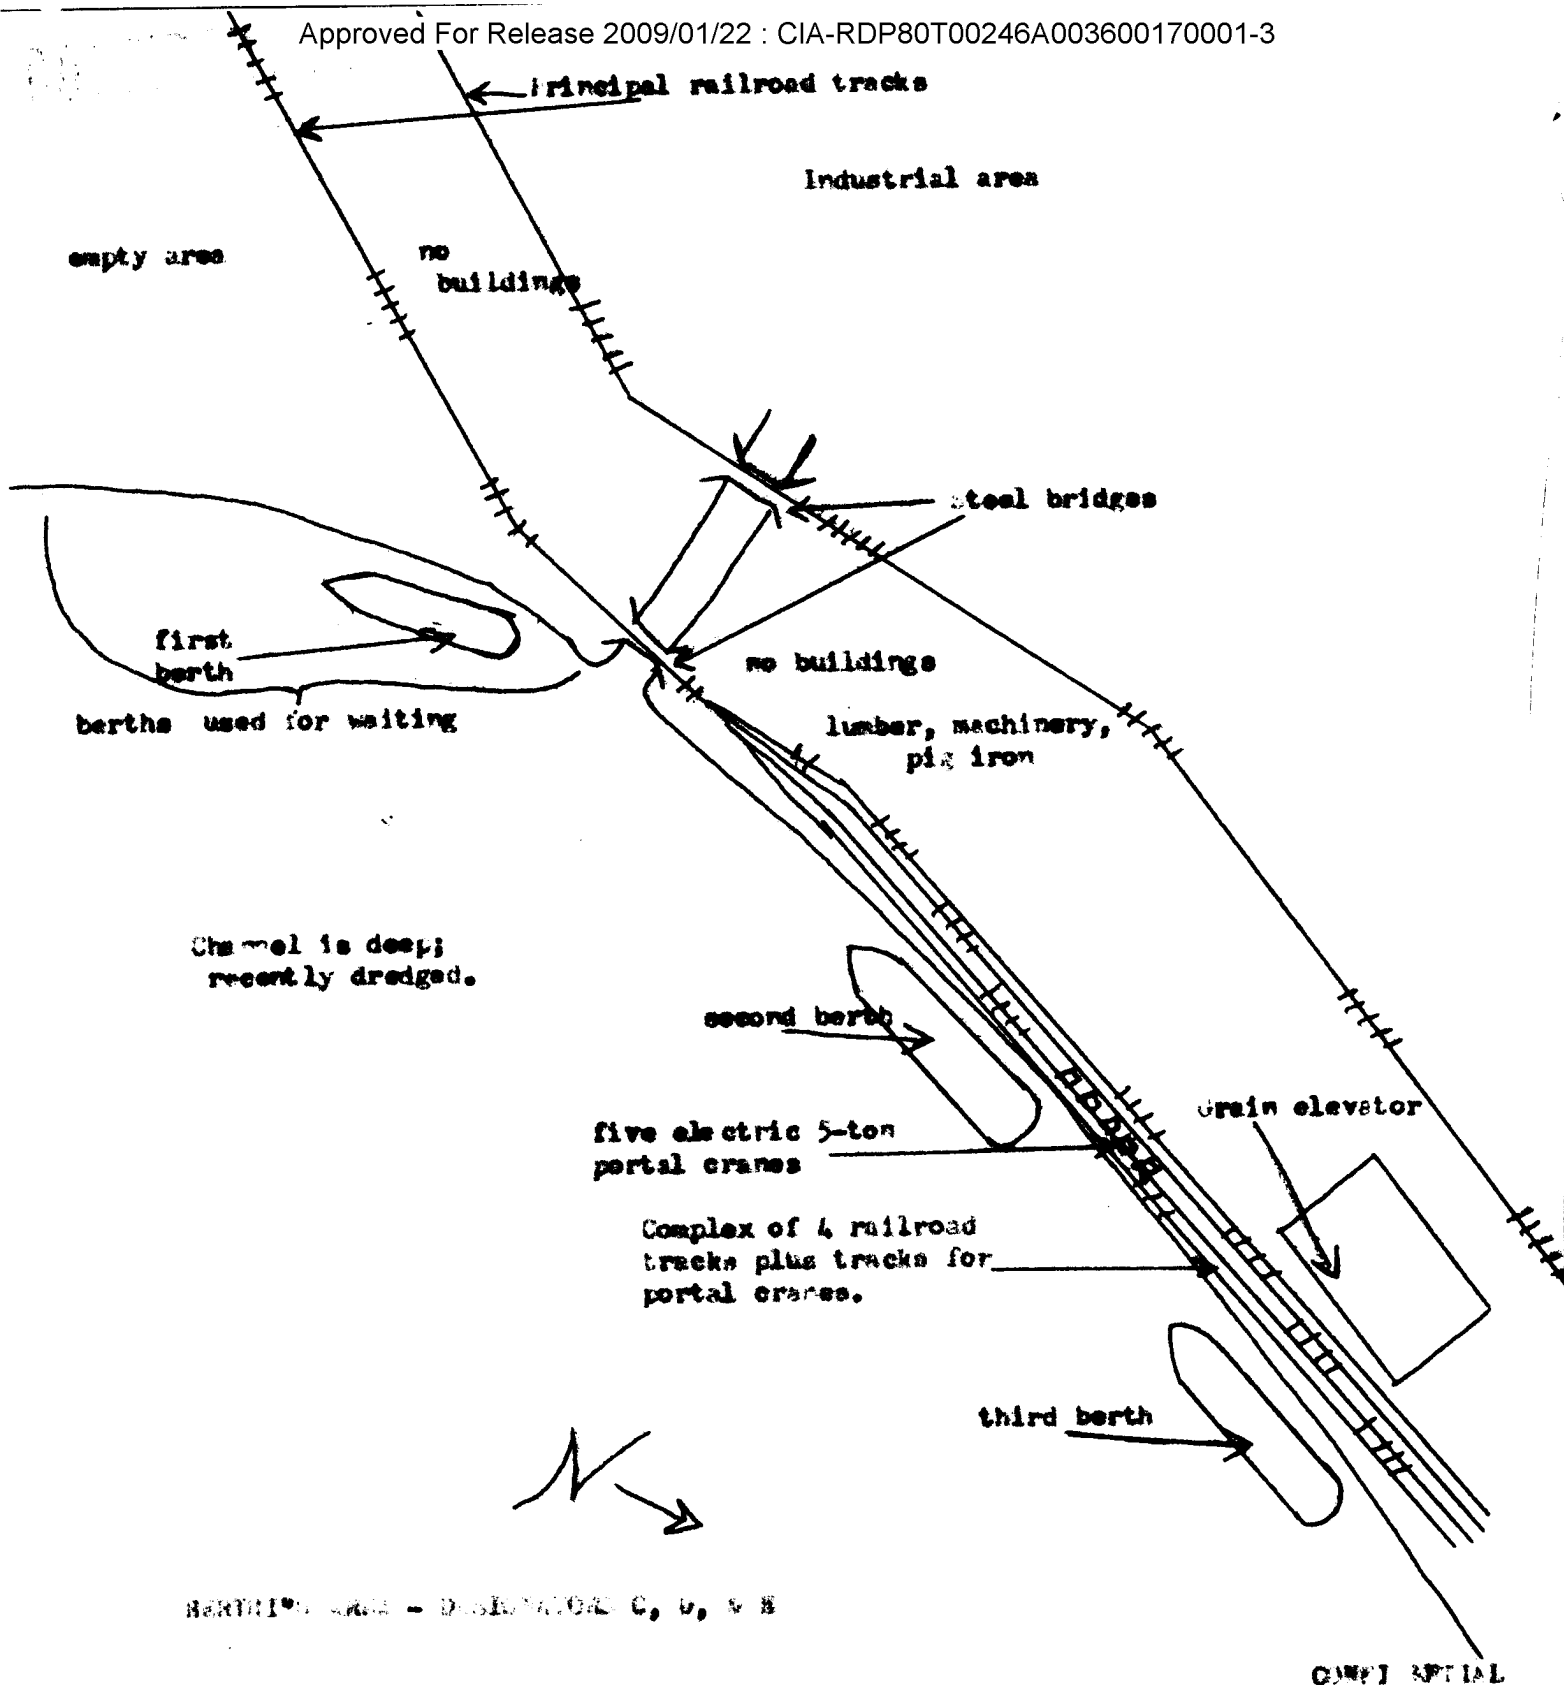
2. Alphabetical Designators In connection with information contained herein, specific points of interest are noted and referred to in this report by the following alphabetical designators:

- A. Wood and cement jetty
B. Pilot aboard
C. First berth
D. Second berth
E. Third berth

- F. Small patrol craft
G. Small patrol craft
H. Soviet merchant ships
I. Soviet tug
J. Previously reported grain elevator
